CALIFORNIA DIVISION OF MINES AND GEOLOGY
FAULT EVALUATION REPORT FER-244

SIMI-SANTA ROSA FAULT ZONE
in the Moorpark, Newbury Park, Simi Valley East¹,
Simi Valley West², and Thousand Oaks Quadrangles
Ventura County, California

by
Jerome A. Treiman
October 5, 1998

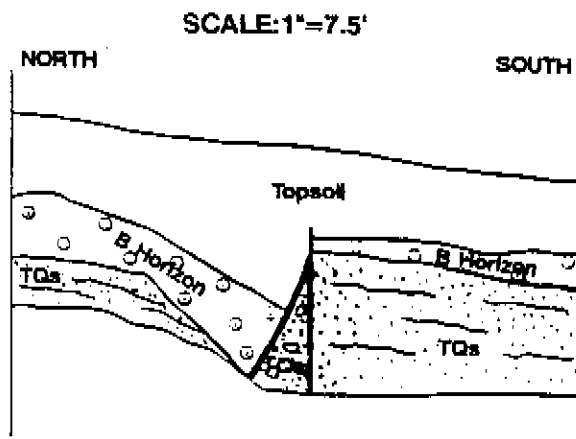
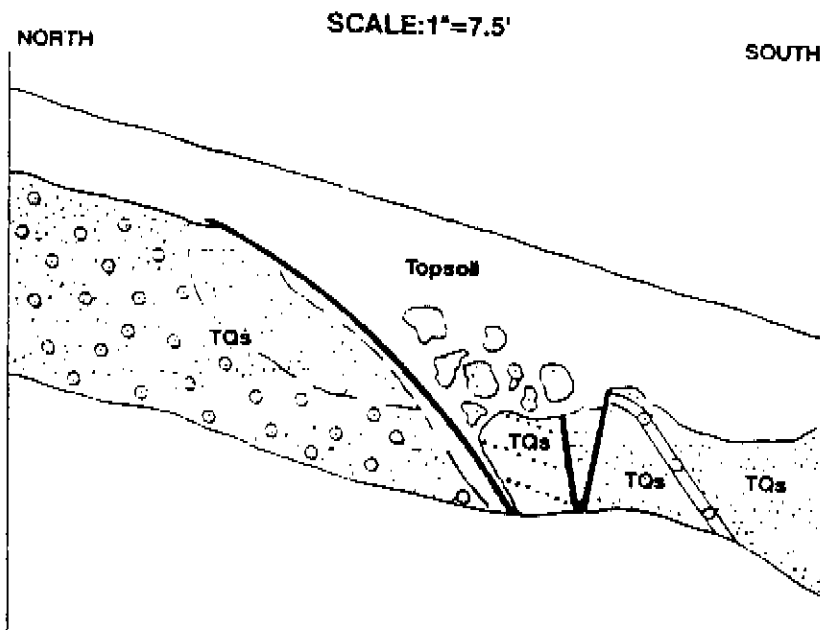
FIGURE A. Log of a portion of Trench No. 1, Fitzgerald Property. Splay fault offsets Saugus Fm. and overlying caliche-enriched B horizon.

FIGURE B. Log of a portion of Trench No. 4, Tract 4298 (Rancho Barasso). Fault offsets Saugus Fm. Bedding north of fault obscured, but dip is slightly shallower than dip of fault.

Figure 4 (FER-244) - A) Portion of consultant's trench log at locality 8b showing displaced topsoil; B) Portion of consultant's trench log at locality 12, showing southern splay of Simi fault extending along soil/bedrock contact, and offsetting base of soil. (Figures from Boales, 1991)

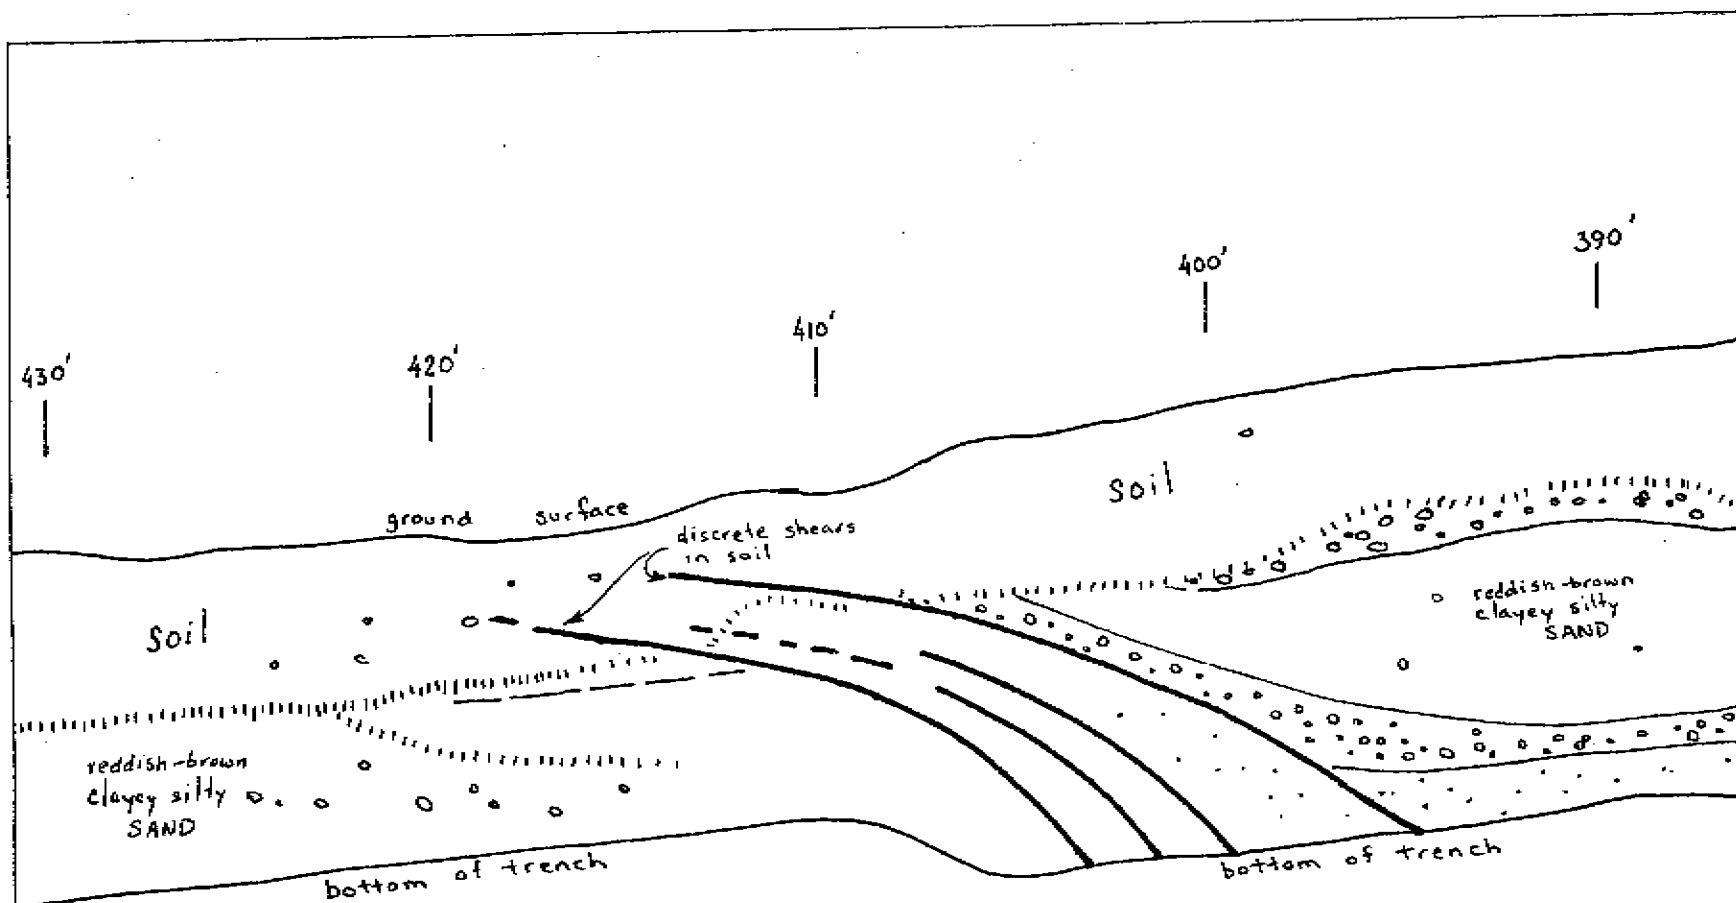
Figure 5 (FER-244) - Sketch log, after Leighton (1996) of a portion of the west wall of trench LT-1 (locality 31a), showing shears extending up into soil. Fault attitudes - N33°E, 50°NW near trench bottom; N27°-35°E, 20°-22°NW in soil. Slickensides trend downdip. Scale: 1"=5' (logged at 1"=10').

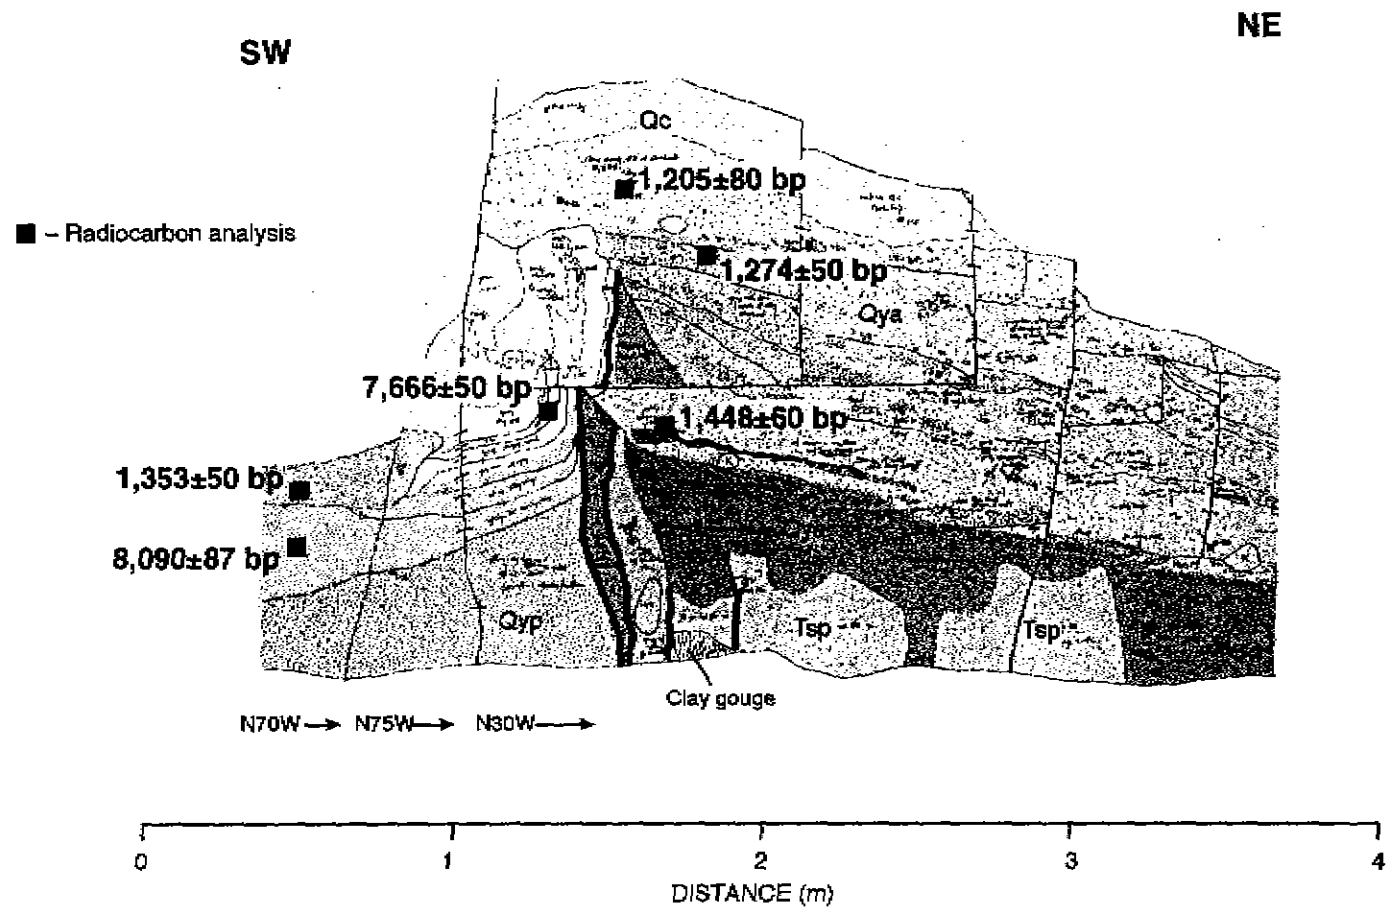
Latest surface displacement on the fault seems to be partially constrained by studies at Arroyo Simi (locality 37) where faulting occurred less than about 7666 ± 50 ybp, but before 1205 ± 80 ybp (Hitchcock and others, 1997, 1998). East of the arroyo, at locality 38 (Figure 2b), latest faulting is either older than 4000 years, or else the trench failed to cross the fault. [Data farther east, at locality 44 (Figure 2c), suggest that the eastern section of the fault has not moved in at least 6500 years. This does not necessarily constrain activity to the west, however].

Figure 6 (FER-244) - Log of west bank of Arroyo Simi (locality 37) showing deformation and offset of Holocene deposits.
(from Hitchcock and others, 1997)

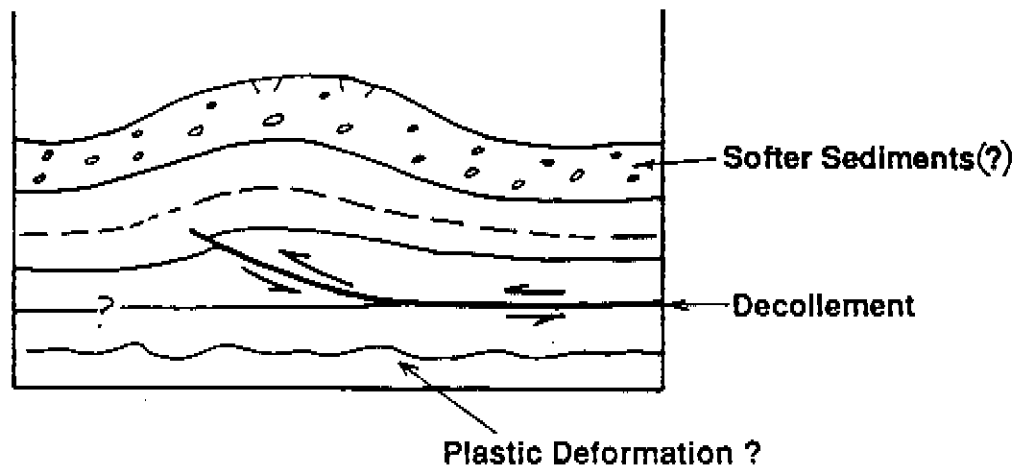
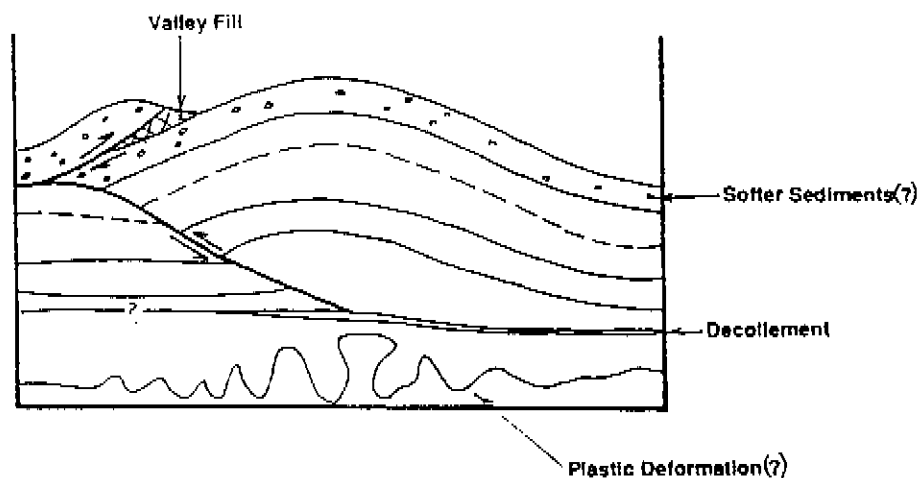
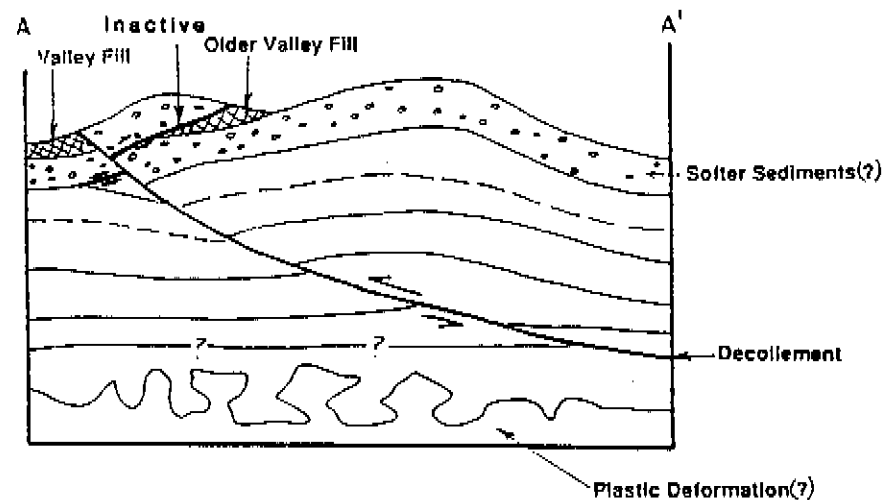
FIGURE 7A - UNIDIRECTIONAL BLIND THRUSTING

FIGURE 7B - INTERCALATION OF TOE OF BLIND THRUST

FIGURE 7C - OVERTHRUSTING AFTER INTERCALATION

Figure 7 (FER-244) - Diagram illustrating the progression of an intercalation backthrust. Illustration (from Whitney and Gath, 1991) is for an area in the western Camarillo Hills, but it is believed applicable also to portions of the Santa Rosa Valley fault.

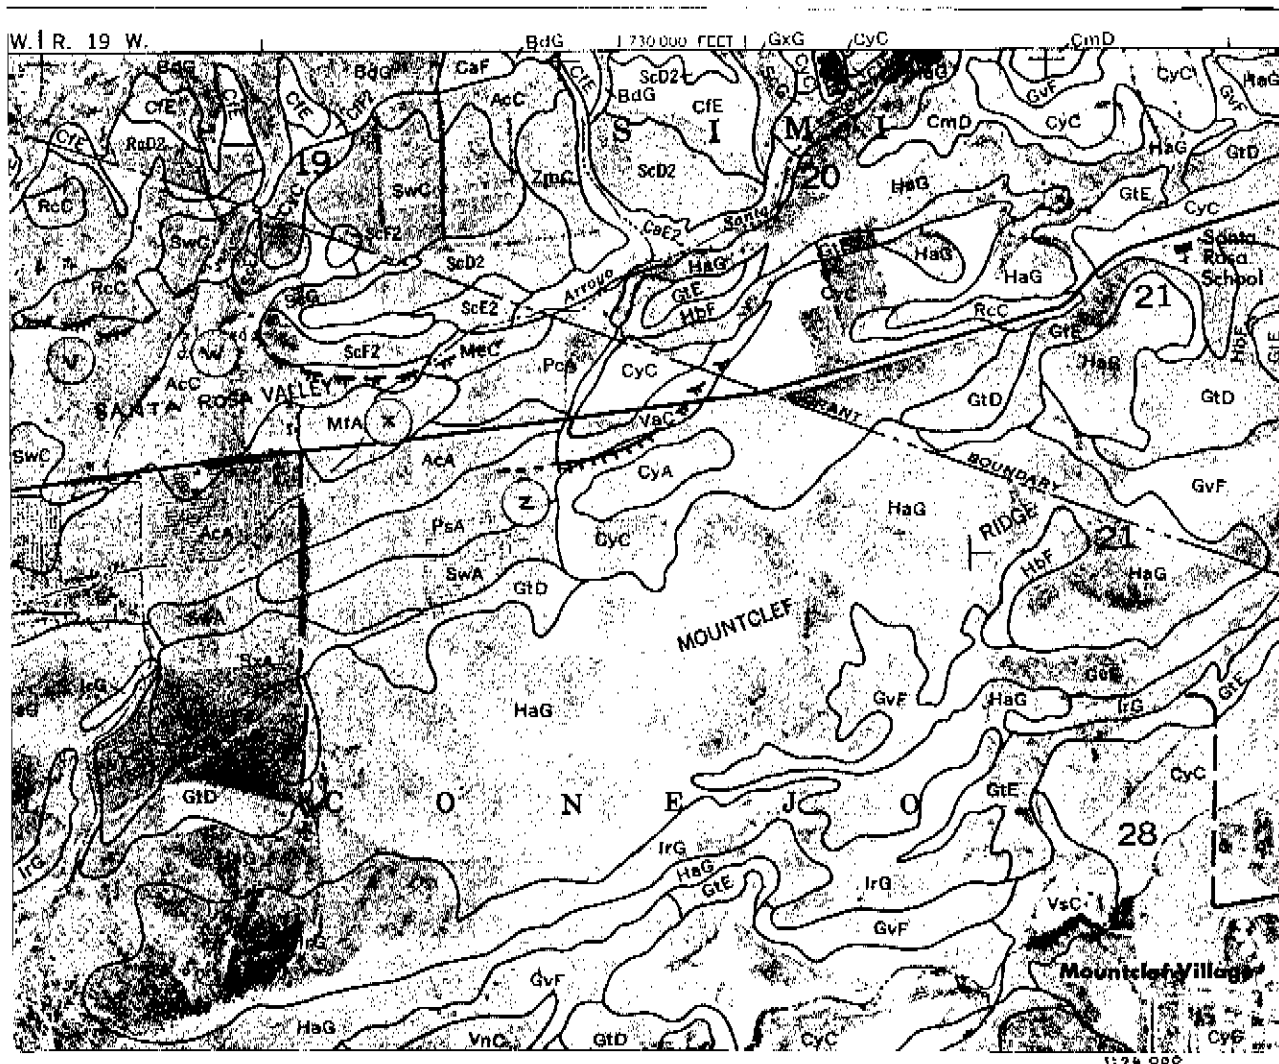
Figure 8 (FER-244) - Detail from Ventura area soil survey (USDA, 1970 - map sheet no.40). Cropley clay (CyC) in center of map is on elevated floodplain above scarp, and on modern floodplain to the south. Vina loam, surrounding CyC, appears as if it might be the Cropley subsoil exposed by faulting. Incised drainage also leaves Cropley clay elevated above fault.
